PRELIMINARY REPORT

ON INVESTIGATION OF AIRCRAFT ACCIDENT

of PA32-301T powered aircraft,
reg. no. N710CC, Predmeja – Ajdovščina,

14 July 2016

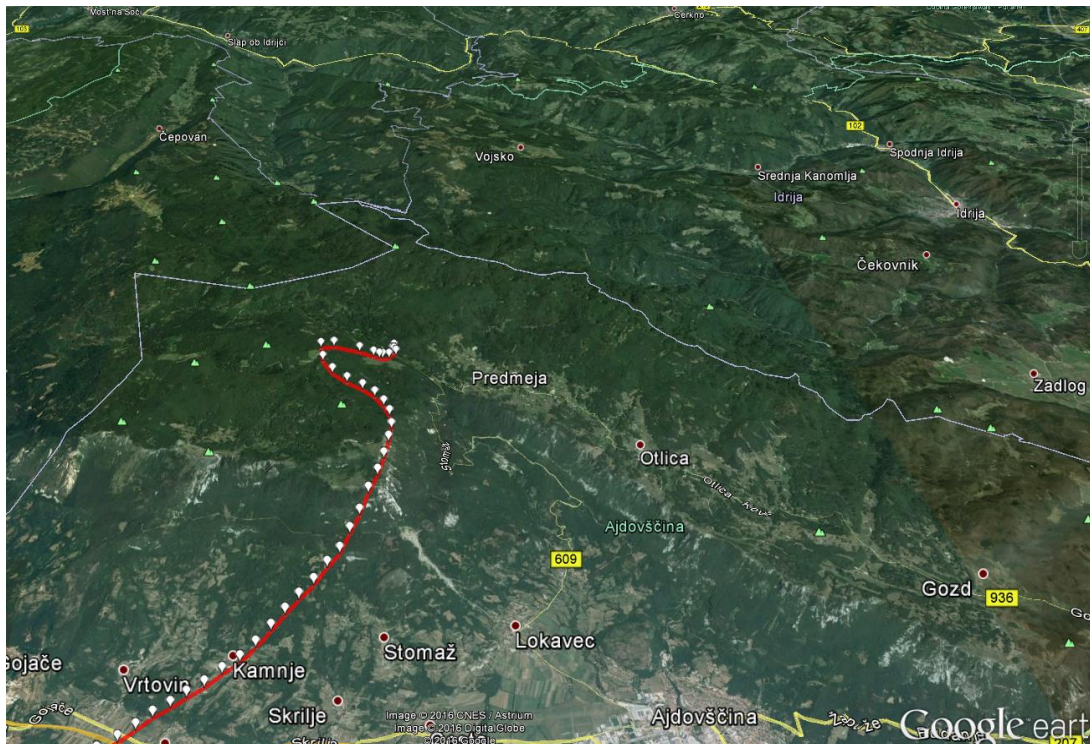
Figure 1: Actual flight route

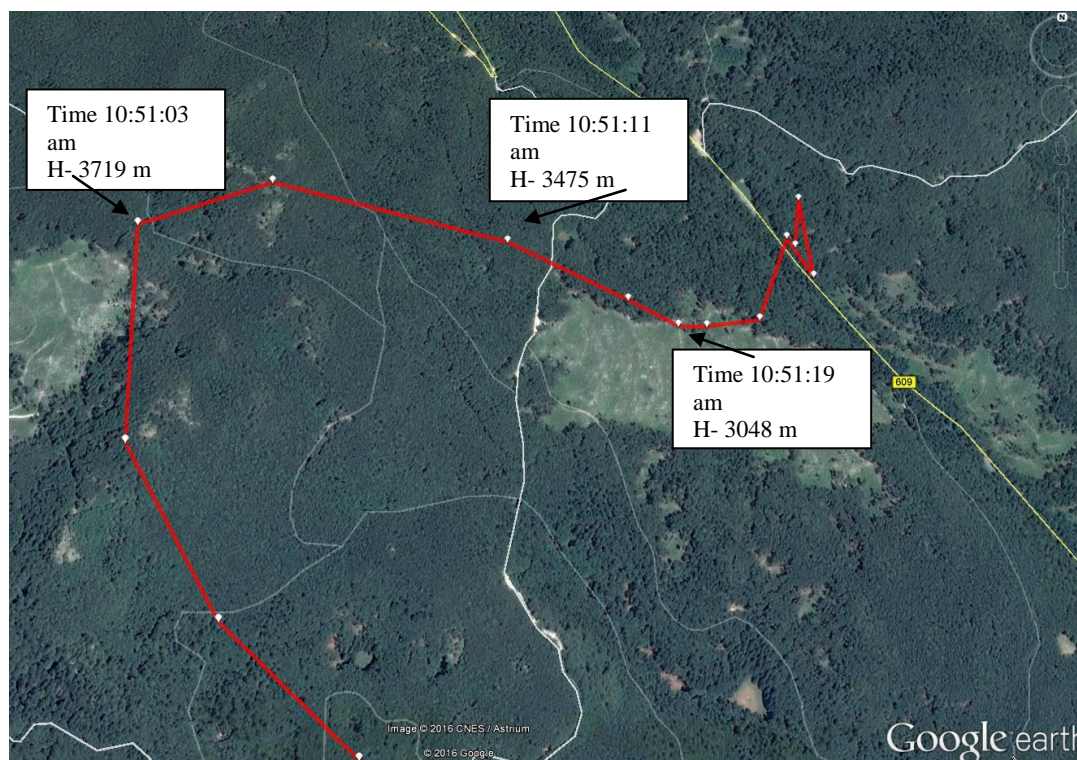
Figure 3: Elements of flight, based on analyses made by the use of radar records

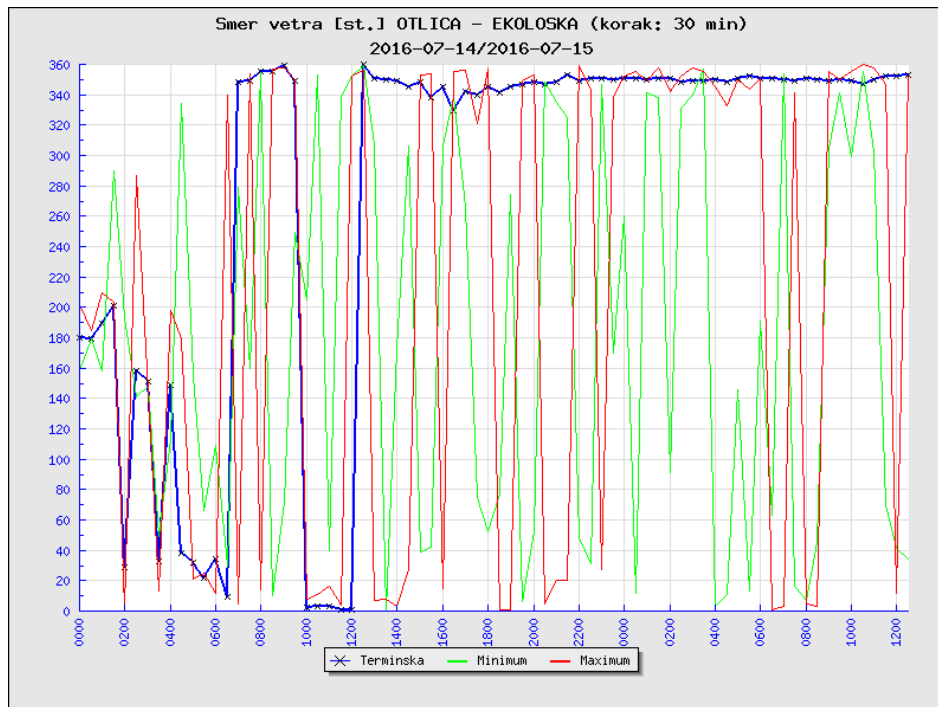
Figure 8: Wind direction at the Otlica station It can be seen that the wind changed direction from south to north in the morning

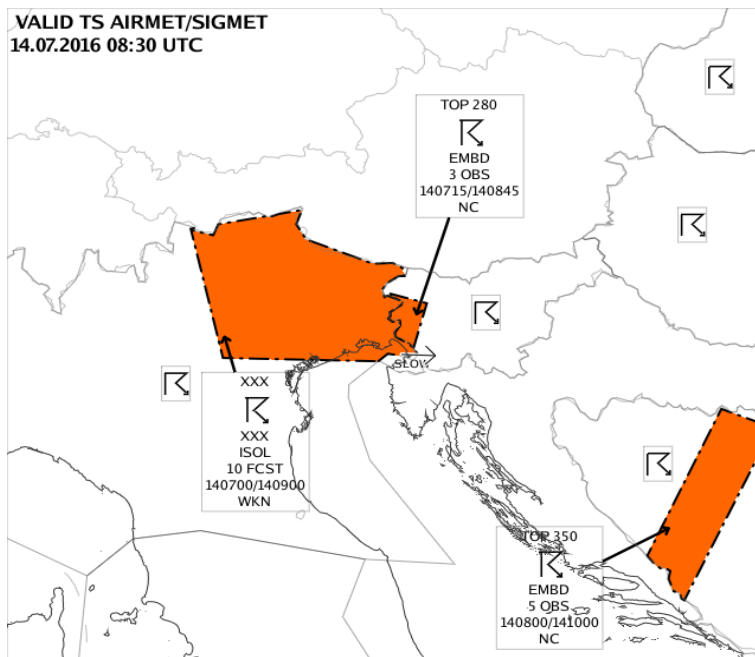
In the period corresponding with the time of the accident, the LJUBLJANA FIR meteorological watch service issued a warning about the formation of storms in the south-west part of LJUBLJANA FIR. The warning was issued at 9.23 am local time.

Figure 11: The airspace area for which warnings about formation of storms had been issued

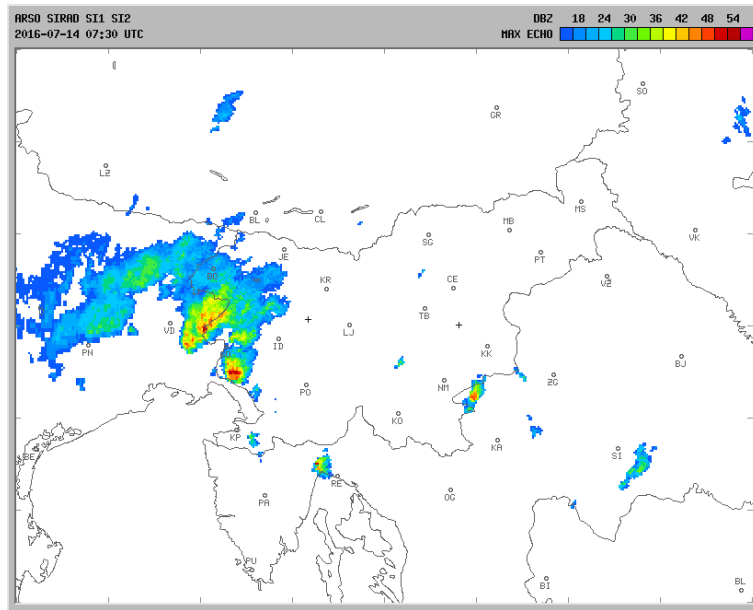
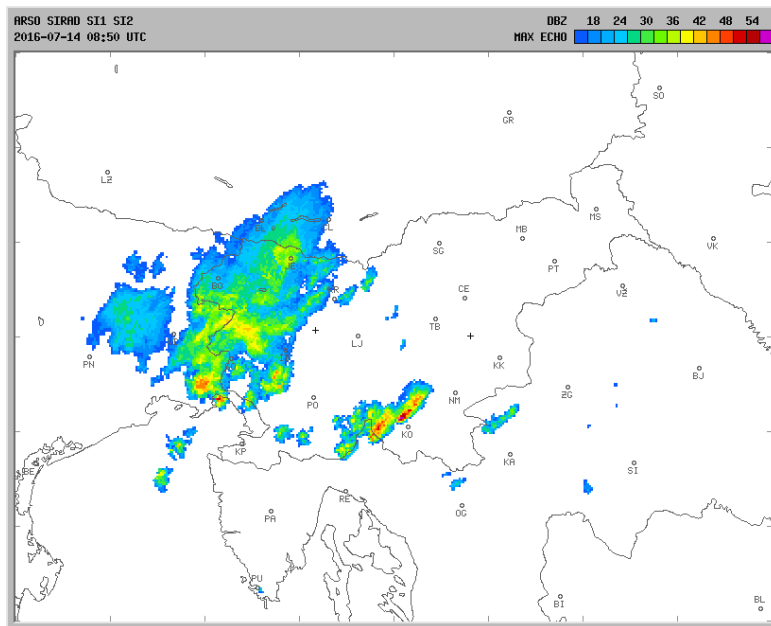
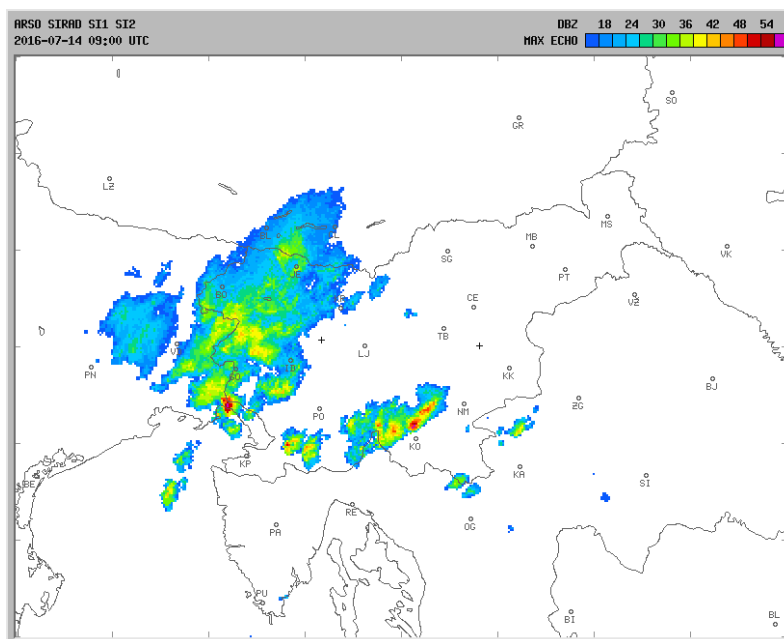
Based on the analysis of sequences in the radar footage, we conclude that the strongest convection formed in the north Primorska from 9 am to 10 am local time; later on, convection activity decreased and rainfall started, particularly showers (figures 10, 11, and 12). A new storm cell developed at the Slovenian border with Italy, i.e. south of Nova Gorica at 11 am local time (figure 12 – red).
